**MARYLAND HISTORICAL TRUST
DETERMINATION OF ELIGIBILITY FORM**

Property Name: Brick House Farm Inventory Number: K-233
Address: 25266 Mary Morris Road City: Chestertown Zip Code: 21620
County: Kent USGS Topographic Map: ~~Chestertown~~ Betterton
Owner: Brick House Farm, Inc. Is the property being evaluated a district? ☐ yes
Tax Parcel Number: 28 Tax Map Number: 34 Tax Account ID Number: 001229
Project: Chestertown Emergency Services Tower (Site II) Agency: DBM
Site visit by MHT Staff: ☐ no ☐ yes Name: _____ Date: _____
Is the property located within a historic district? ☐ yes ☒ no

MARYLAND HISTORICAL TRUST
NR-ELIBILITY REVIEW FORM

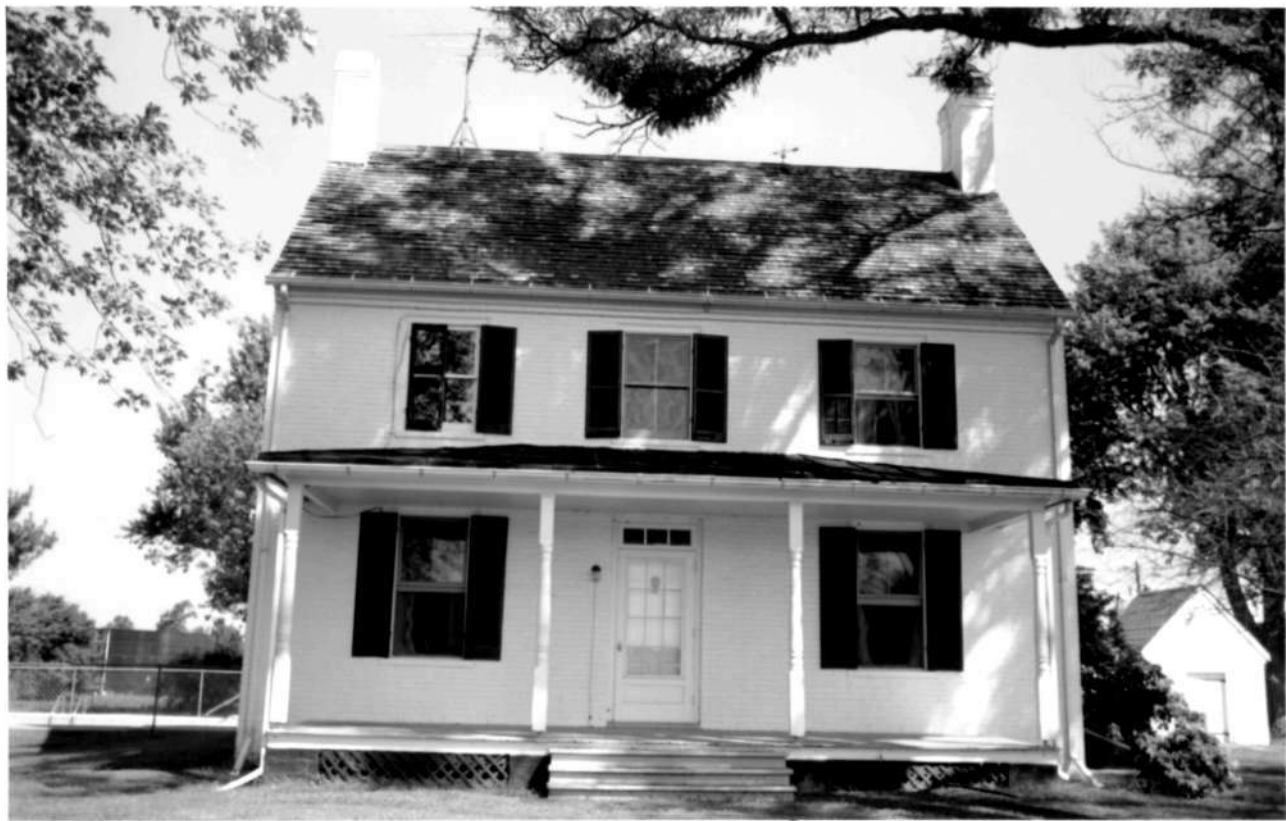
1/5

View of the facade of the brick farmhouse

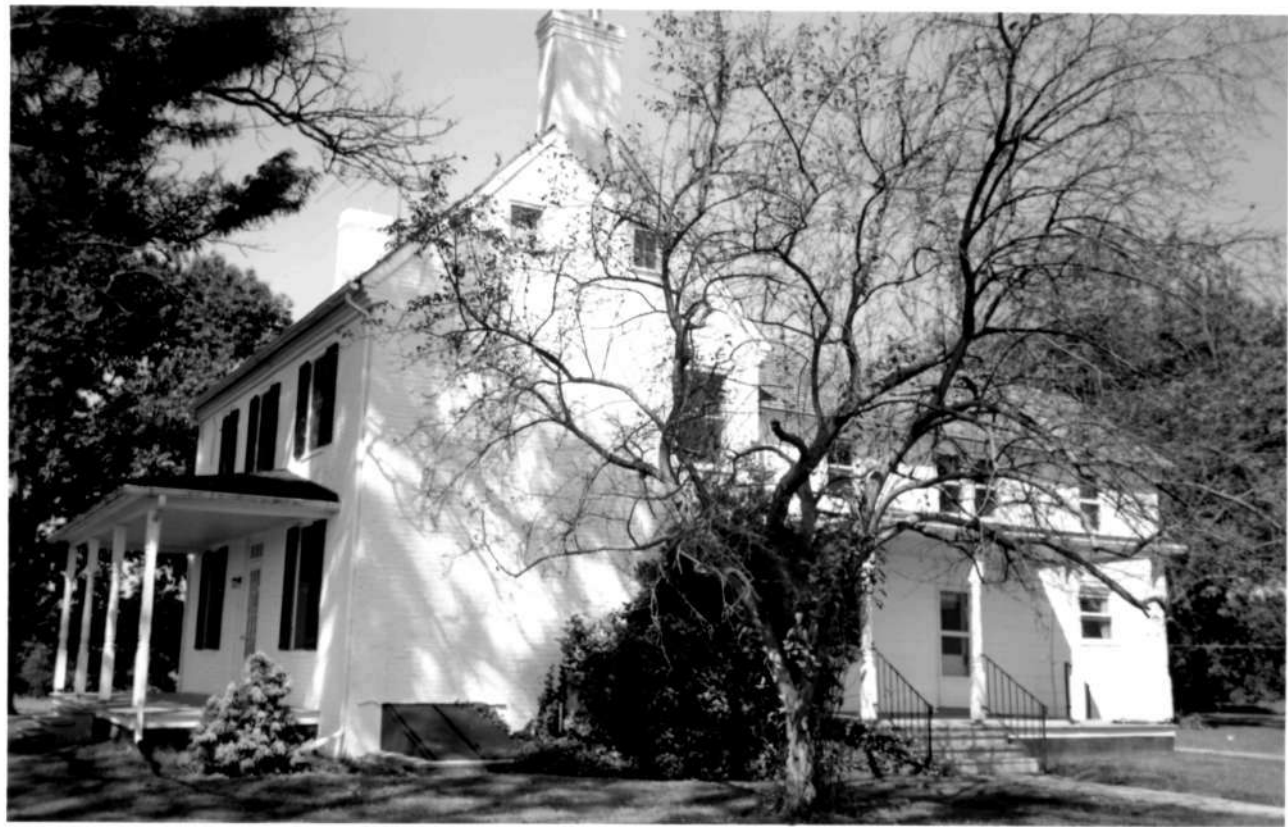
2/5

View of the north side of the house depicting
the moved frame kitchen wing.

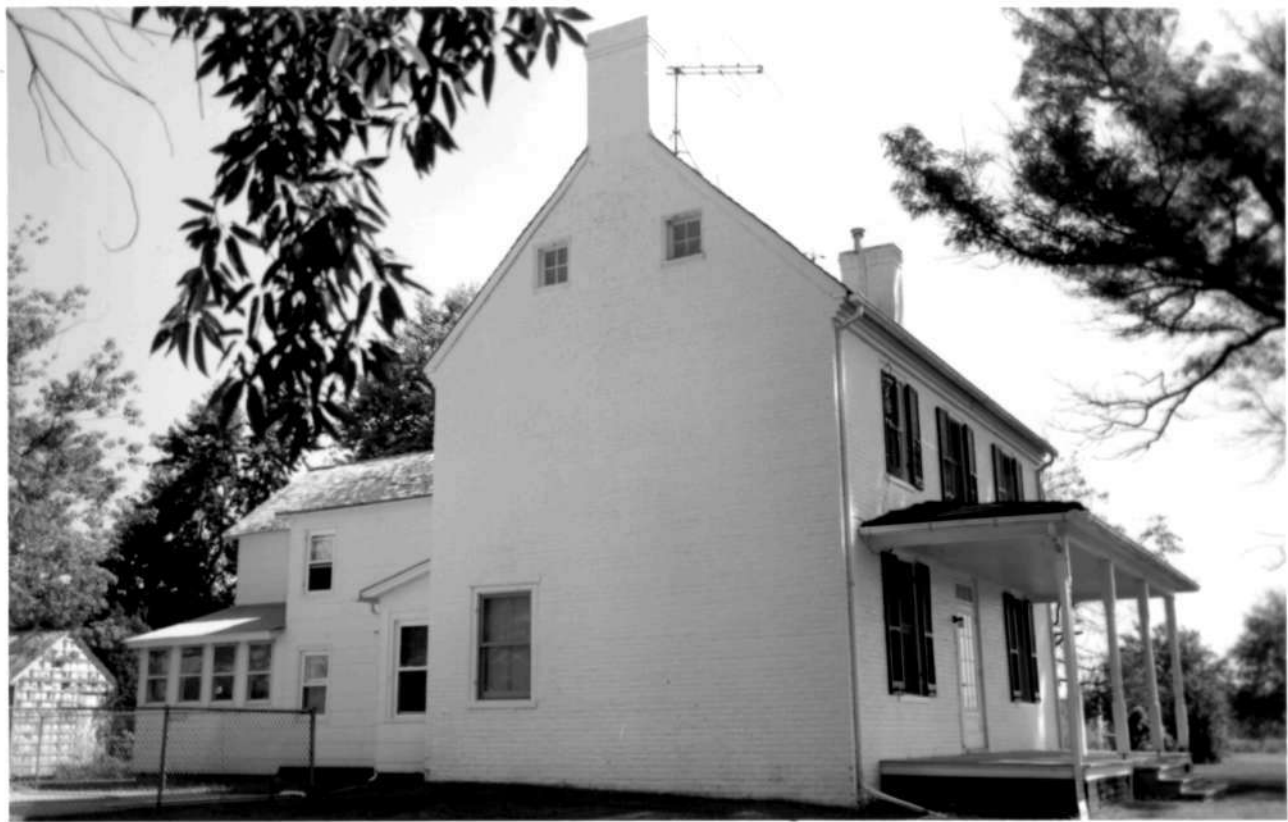
3/5

View of the South side of the house.

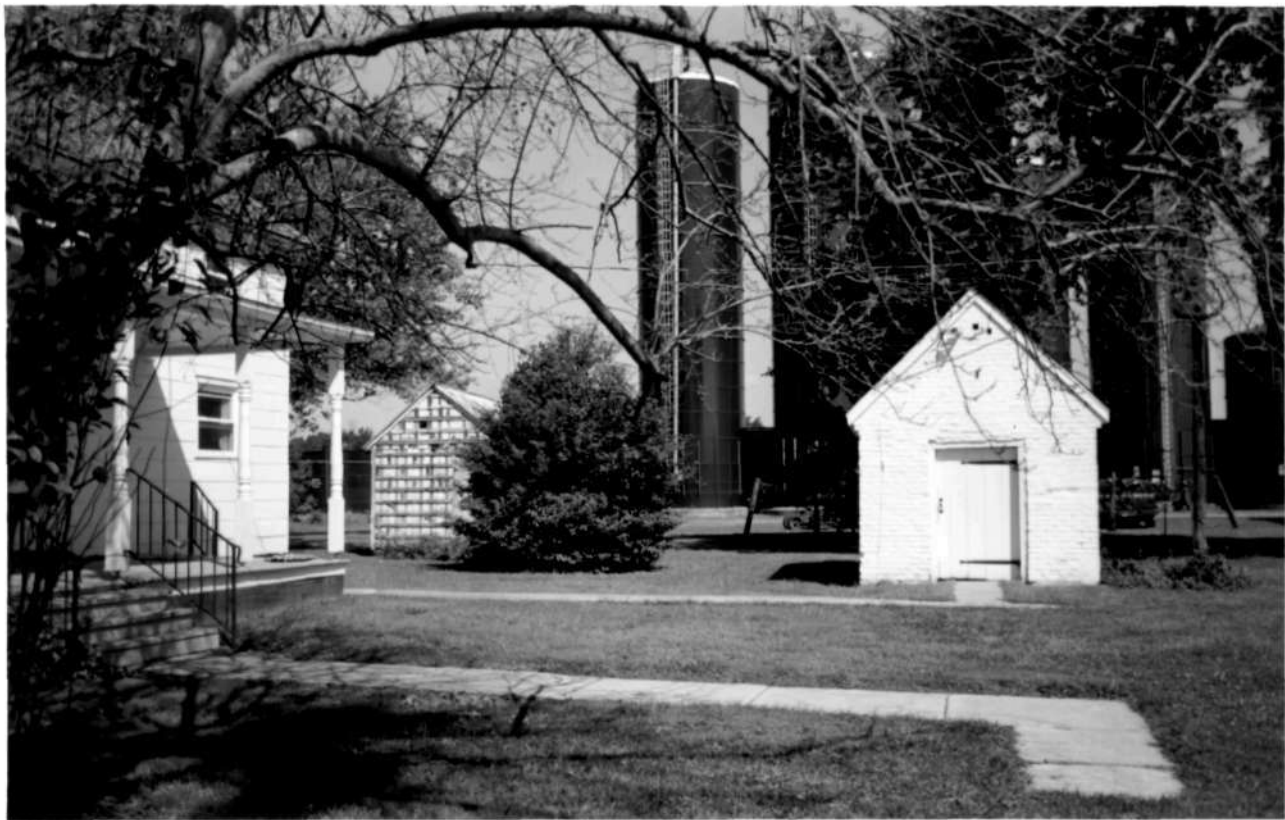
4/5

Several outbuildings associated with the farm remain on the property. One of particular significance is a small white brick smokehouse with the same corbelled eaves as the main brick house. The small structure has a vertical board door with iron strap hinges and arrowhead details.

View of the small brick outbuilding located
just northwest of the house.

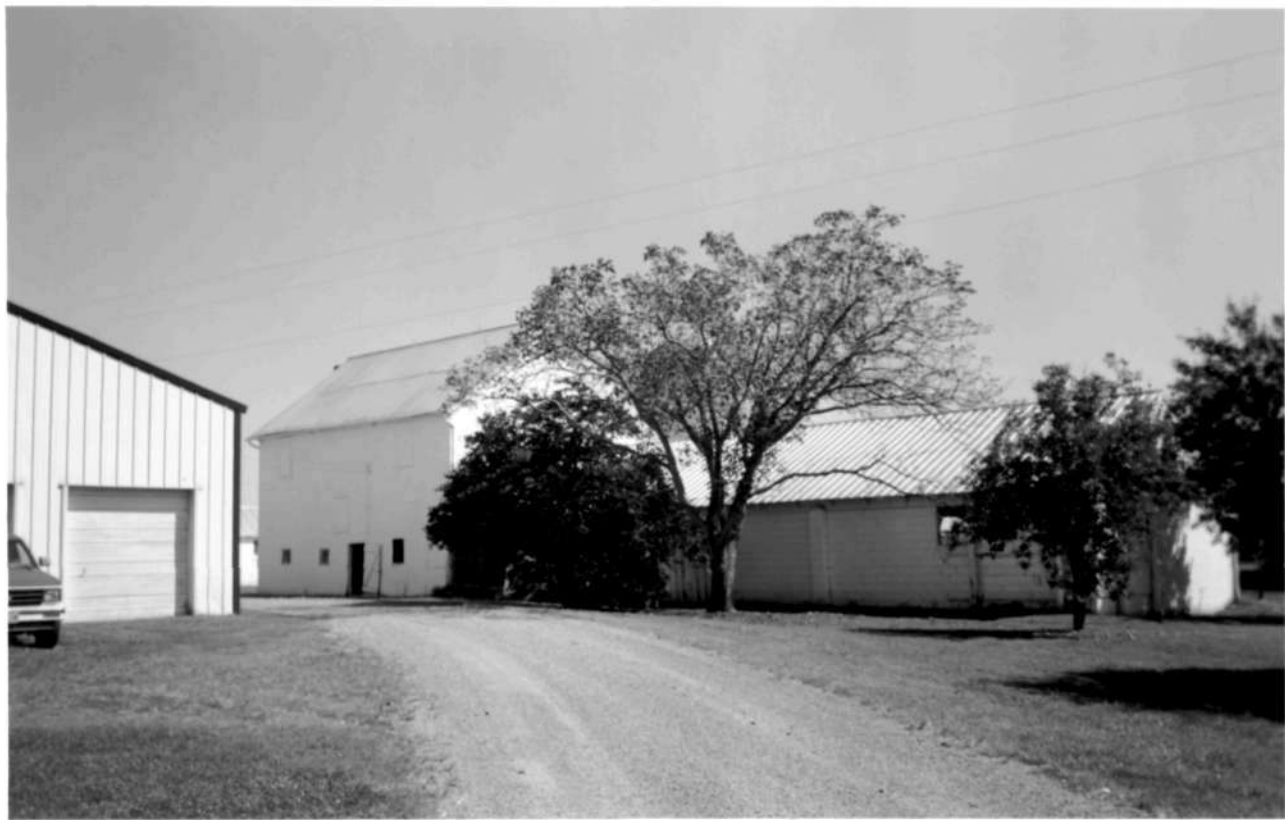
S/S

A hay barn, possibly dating from the late 19th Century also remains on the property, though it has been updated significantly. A small frame building, possibly a milk house, is located west of the kitchen addition. Other structures are of a recent construction period to suit the needs of this working dairy farm, such as silos, dairy barn, metal storage garages, etc.

View of barns and other outbuildings on the
property.

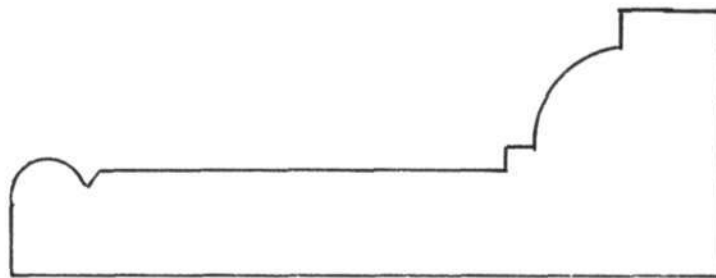
K-233
Original Trim
First and Second Floors

The two original rooms in the brick section are unchanged in size and shape although some detailing was altered in 1905. Elsewhere, window trim is a bead and quarterround, as shown below, and it remains on most windows and doors. Where changes have been made and in doors or windows in or associated with the hyphen, simple flat reeded trim is used. Early six-panel doors are found on the second floor of the brick section and there is one five-panel door, probably in its original frame, in the old frame wing. This element as well as wide yellow pine flooring are the most significant indications that the frame section is contemporaty with the brick one.

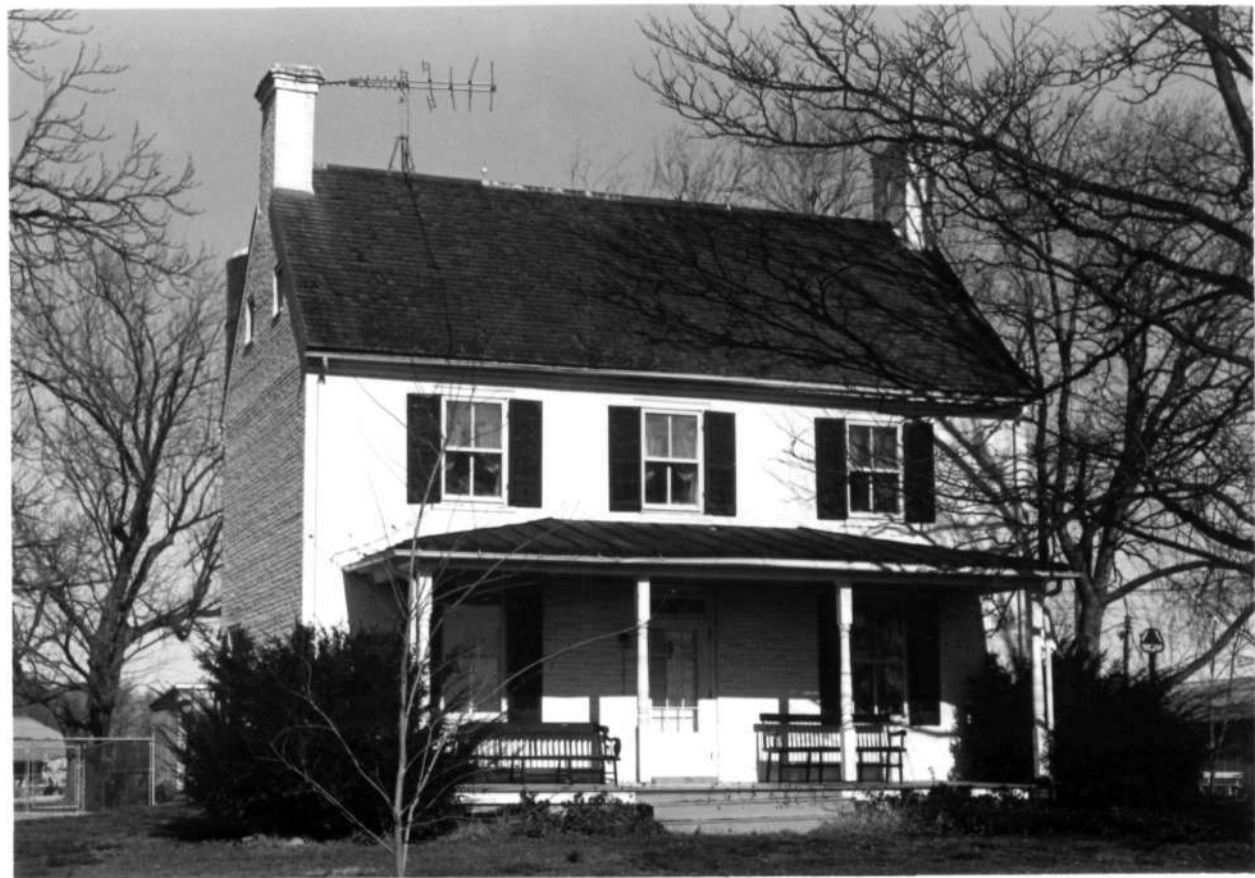
Brick House Farm
View to the North
